ACCURATE QUANTIFICATION AND FOLLOW UP OF RAIL CORRUGATION ON SEVERAL RAIL TRANSIT NETWORKS

Tom Vanhonacker
APT, Mechelsevest 18/03, 3000 Leuven, Belgium
tom.vanhonacker@aptrail.com

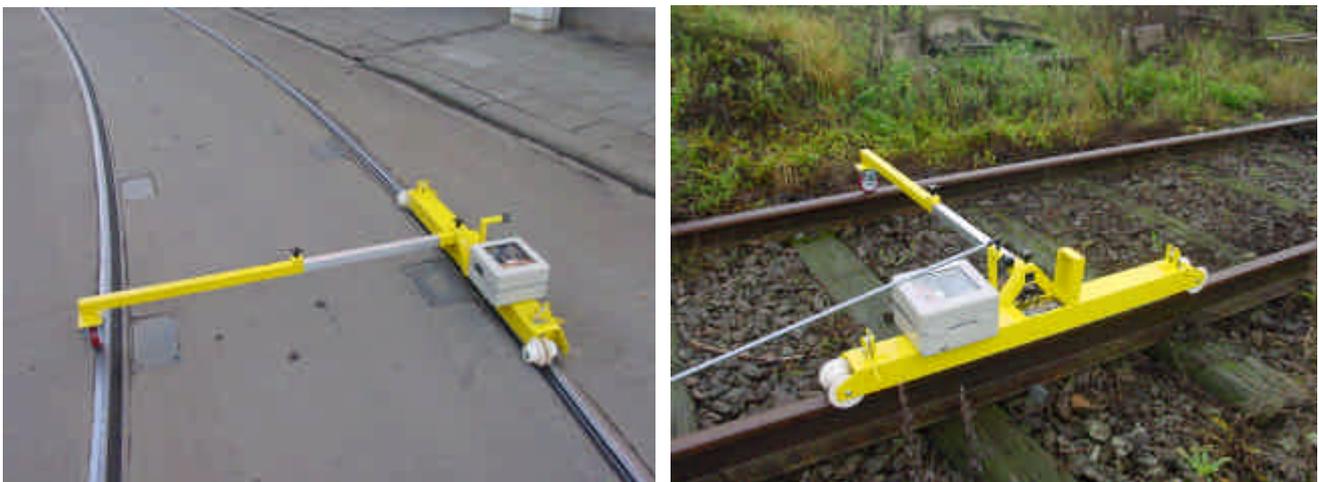
Figure 1: Rail Surface Analyser on embedded tracks and ballasted tracks

Within the scope of the Corrugation project, a portable, affordable, easy to use measurement device was developed as no suitable product was commercially available to quantify corrugation in terms of their wavelength and amplitude on a large scale and on several different networks. This device is now commonly used and referred to as Rail Surface Analyzer (RSA-figure 1).

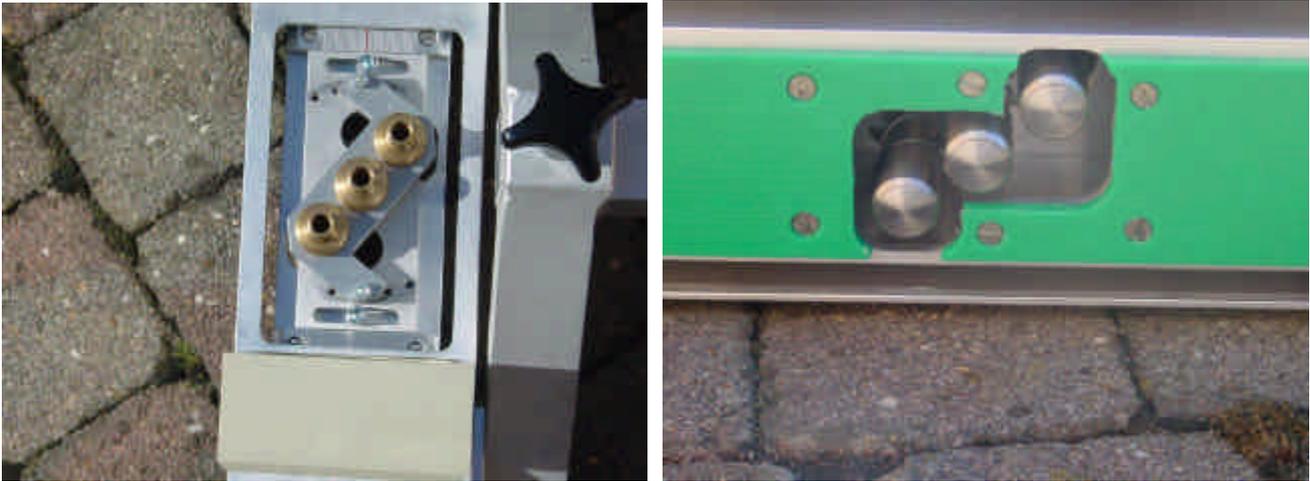
The roughness measurements are performed by three contact making displacement sensors inside the housing of the Rail Surface Analyzer (see figure 2). The device is manually pushed forward by one person at walking speed (3.6 km/h).

Figure 2: Three adjustable but equidistant contact making measurement probes with a large contact radius

The Rail Surface Analyser does not remove negative spikes in the processing of the measurement data but during the actual measurement: the displacement sensors have a larger contact radius (figure 2) and as a consequence, the sensors feel the same roughness as experienced by the vehicle wheel (Cordier et al, 1999). Optionally and depending on the application of the roughness measurement, the shape of the contact probe can be modified to a smaller radius. Positive spikes can be eliminated in the processing by setting a spike detection threshold and a spike edge criterion. The spike is then replaced by linear interpolation of the signal. The processing of the measurement data without spike removal mainly influences the shortest wavelengths (<20 mm) and is less visible in the longer wavelengths.

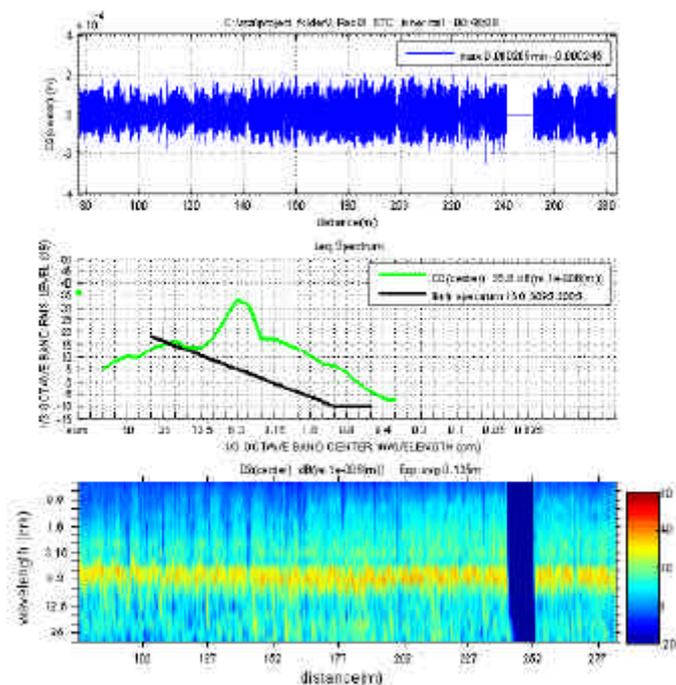
The roughness spectrum (figure 3) shows the dependency of the roughness level on roughness wavelength. The upper plot shows the vertical rail deviation (m) in function of the distance along the rail. The middle plots shows the Leq spectrum, averaged 1/3 octave band RMS level of the vertical rail deviation in dB (re.1e-6m) as function of wavelength in cm. This Leq spectrum is averaged over the selected distance in the upper plot and corrected for the excluded zones. The spectrum is automatically compared to the limit spectrum in the ISO. To summarize these results, the lower plot shows a colored spectrogram which is a combination of wavelength (cm), distance along the rail (m) and amplitude of vertical rail deviation in dB (re.1e-6m).

Figure 3: Typical measured roughness spectrum

Spectral analysis is applied to the signal to produce the 1/3-octave band roughness wavelength spectrum. This is not done via Fourier analysis but directly via band filter of the measurement data. The result of this processing is demonstrated in the figure below.

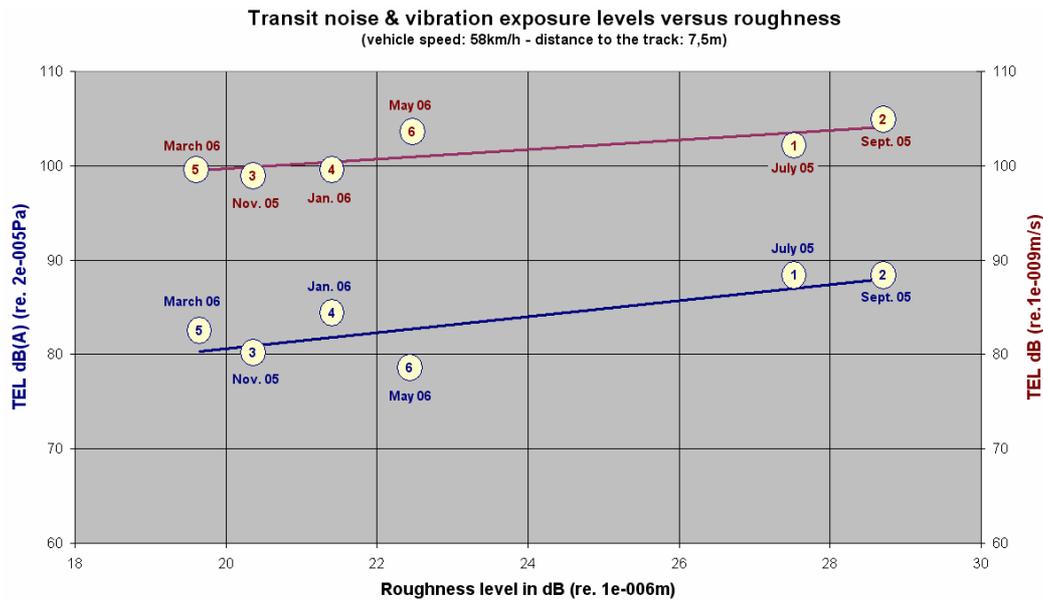
Measurement results clearly indicate that the vibration level is linearly dependent of the vehicle speed while the relation between the noise level and the speed is logarithmic. The transit noise and vibration exposure levels at an average speed of 30 km/h at 7.5 m from the track centerline are plotted against the average measured roughness spectra (figure 4). The trend lines indicate that an increase in vibration level of 7.5 dB at 30 km/h and 5 dB at 58 km/h for an increase in roughness of 10 dB. The grinding of the tracks is responsible for the decrease in roughness, noise and vibration levels between September 2005 and November 2005. The global reduction in roughness level is about 8 dB.

Figure 4: Transit noise and vibration exposure levels vs roughness at 7.5 m from the track with a vehicle at 58 km/h.

There are some deviations from the global trend which are probably due to the different weather conditions, small variations in wheel roughness levels etc. Spectral analysis of the roughness levels before and after grinding indicates that grinding reduces the roughness mainly between the wavelengths 500 mm to 2 mm (corresponding with 31 and 800 Hz at a velocity of 60 km/h). This corresponds with the spectral analysis of the vibration levels before and after grinding, which indicates a reduction of the 40-63 Hz peaks after grinding. The noise is mainly reduced between 250-800 Hz after grinding.

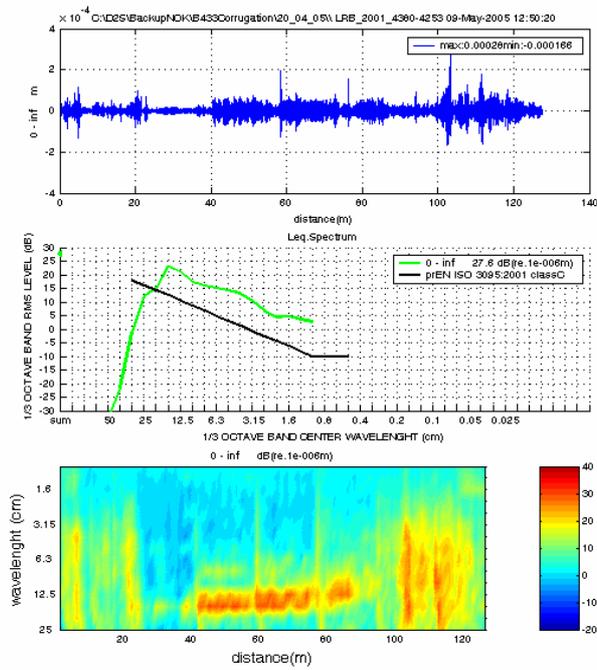
The result of the corrugation measurements carried out on one of the rails before installation of the very resilient rail fasteners is given in figure 5 as measured in April 2005; this was 8 months after the complete removal of the corrugation by grinding. An average corrugation amplitude over the complete length of the curve of 34 μm has been measured with a wavelength of 150 mm.

Figure 5: Spectral analysis of the roughness levels at Brussels Metro, measured 8 months after grinding

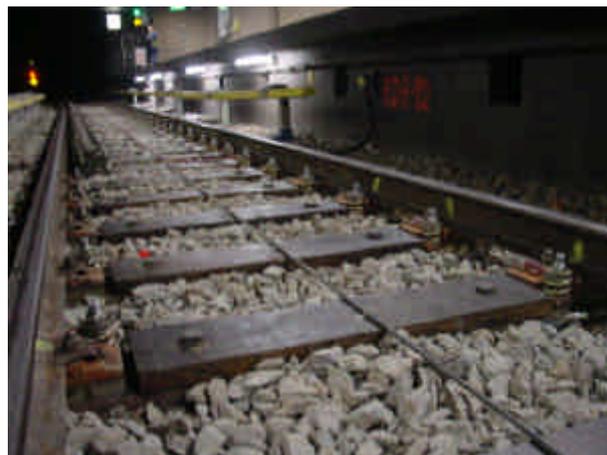
Numerical simulations demonstrated it was necessary to develop a rail fastening system with a vertical dynamic stiffness below 10 kN/mm in order to avoid track resonances corresponding with the 20 to 200 mm corrugation wavelength range. A direct fixation system with the above described stiffness requirements was developed and installed at the complete test section (figure 6).

Figure 6: Detail of the very resilient fastening system

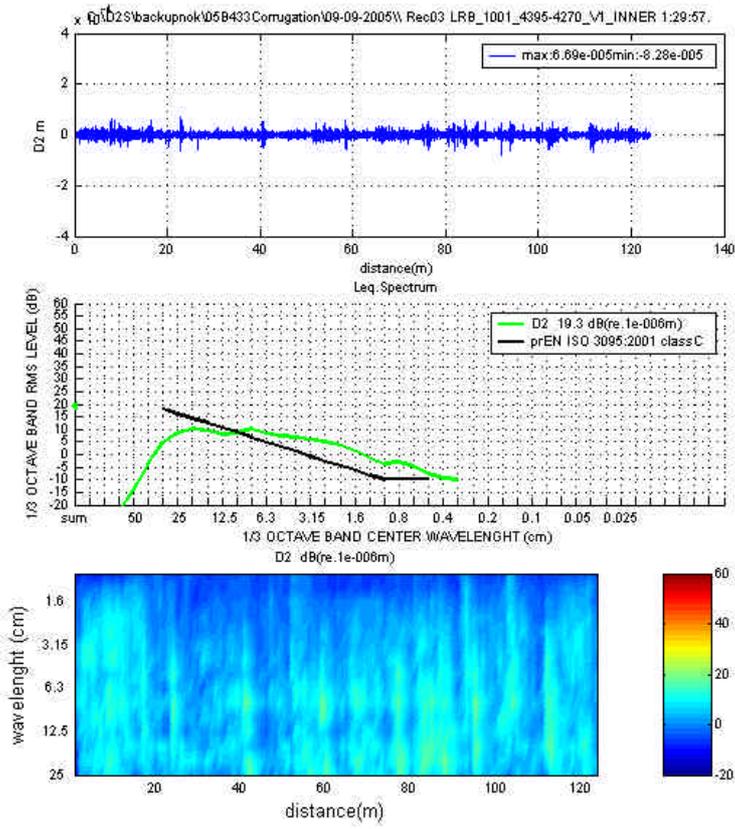
The existing corrugation was removed by installing new rails on both tracks. Rail roughness was monitored 3, 5, 14 months after installation of the fasteners. The results of the measurements after 3 and 14 months are given in figures 7 and 8 below (this is for the same rail as was measured before installation of the fasteners):

Figure 7: spectral analysis of the roughness spectra 3 months after installation of the resilient rail fastener (and new rail)

A detailed analysis of the measurement results shows that no corrugation can be found on the modified tracks, even after 14 months. The solution to use very resilient rail fasteners to avoid vertical anti-resonance in the low frequencies was validated to be effective for Brussels Metro.

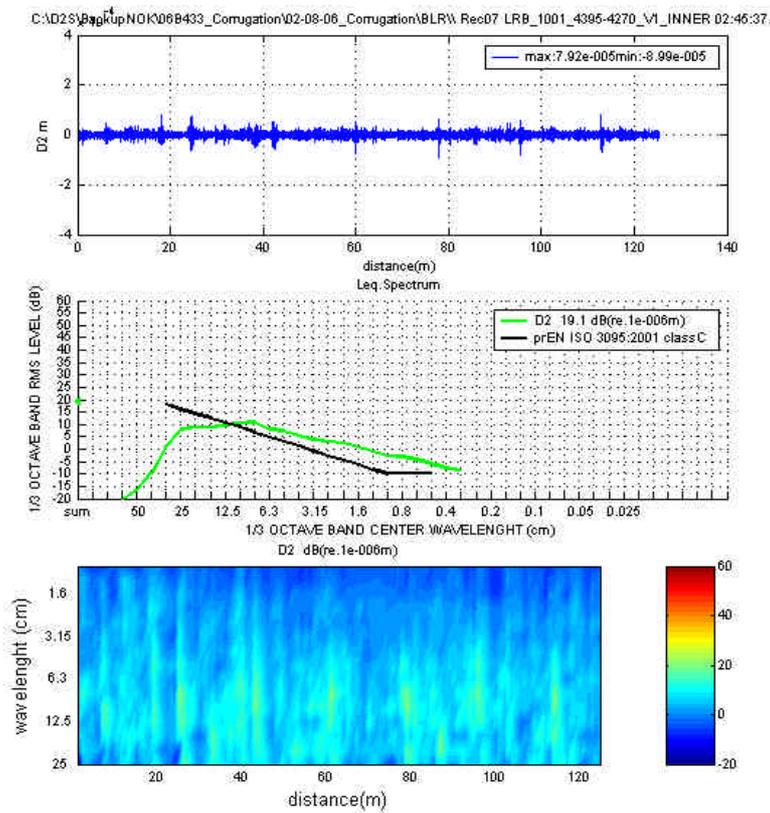
Figure 8: spectral analysis of the roughness spectra 14 months after installation of the resilient rail fastener
