CASE STUDY: DATACENTER SHOCK & VIBRATION SURVEILLANCE

Customer	Dexia Bank Belgium (DBB)
Location	Vilvoorde, Belgium
Duration	Feb 2008 – June 2009
Application domain	Construction works, IT infrastructure

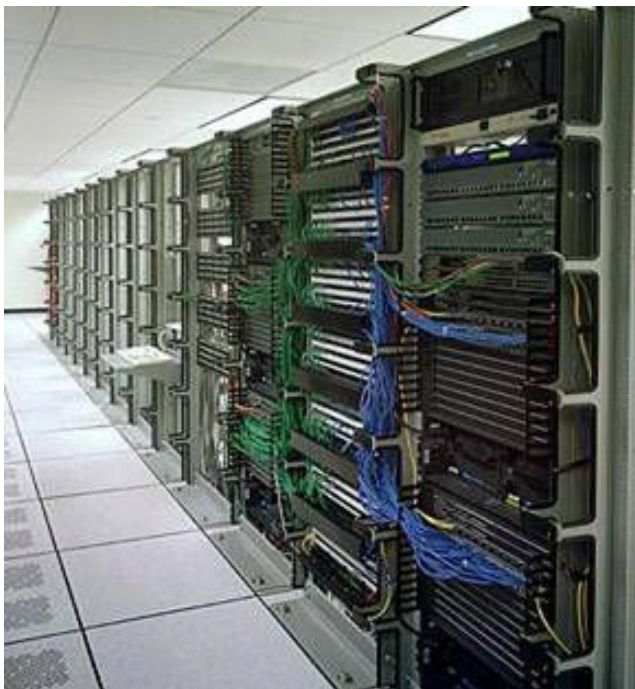
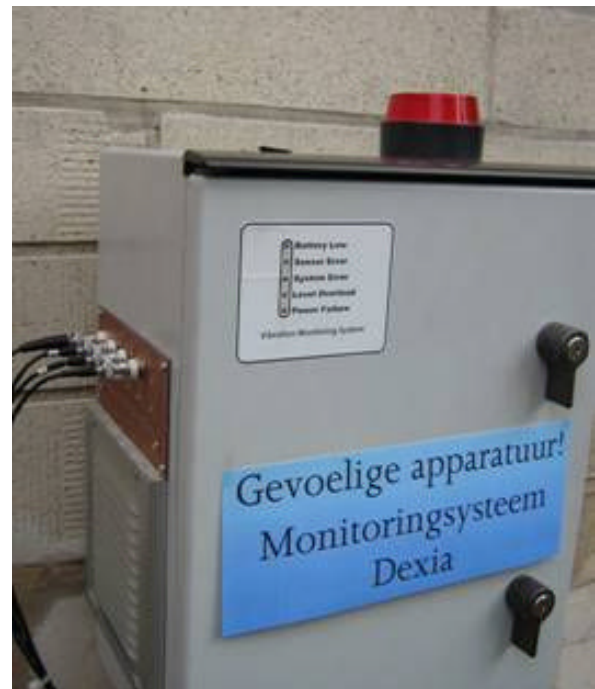
A specific requirement in this project was to have a real-time evaluation of the applicable norms with regard to shock and vibration on electronic equipment in order to immediately stop construction activities in case of transgressions. This requirement could only be met with the computation power of the APT monitoring system.
